# EASY FIXES FOR MCX COOLANT PUMP

## Debris in Check Valve Assembly

## Debris in High Pressure Switch Assembly

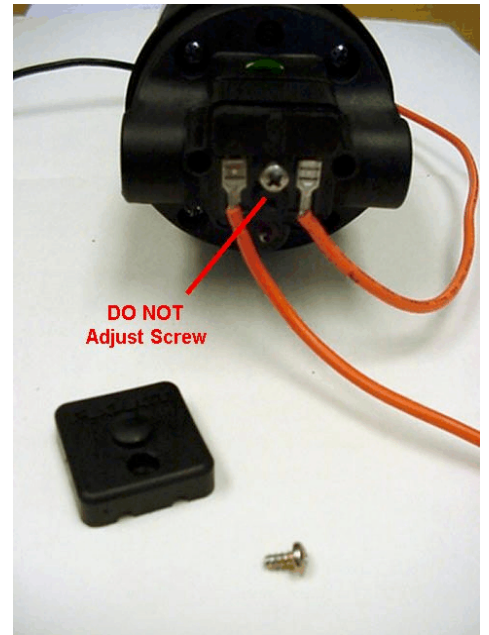
Remove the two small screws and remove the cover over the two orange wires as shown to the right. **Briefly** jumper the two orange wires and see if the pump starts running. If it does, the pressure switch mechanism may be blocked by a small piece of debris. Continue below.

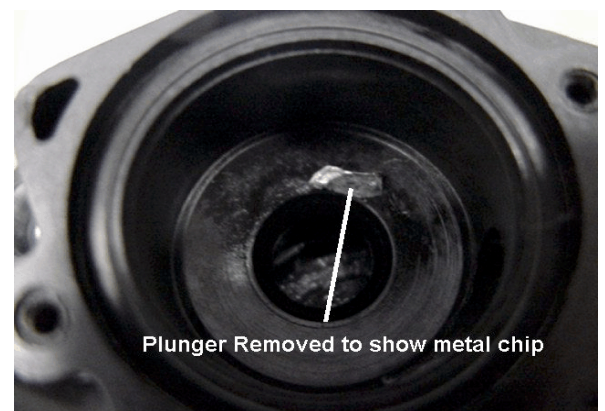
The piece of debris will typically be under the Plunger. The photos to the right show the debris under the plunger and the same piece of debris after removal of the plunger.

**DO NOT CHANGE EITHER ADJUST SCREW**
