Bulletin No: 562-80007-00
 Issued: September 4, 2007

Subject:	Pilot Valve Replacement
-----------------	-------------------------

Model Numbers Affected:	NTF-15 Plus & NTF-60 Plus
Manufacture Dates:	All
Serial Numbers Affected:	All
Tools Required:	As Required
Parts Required:	Pilot Valve: P/N 022-80135-00 (Shown in photo below) Replacement Kit: P/N 355-80098-00 (Includes 022-80135-00 and this document explaining installation).
Supplemental Document:	None
Action Required:	Ensure Pilot Valve is installed properly and that plastic plug is removed from the proper port.

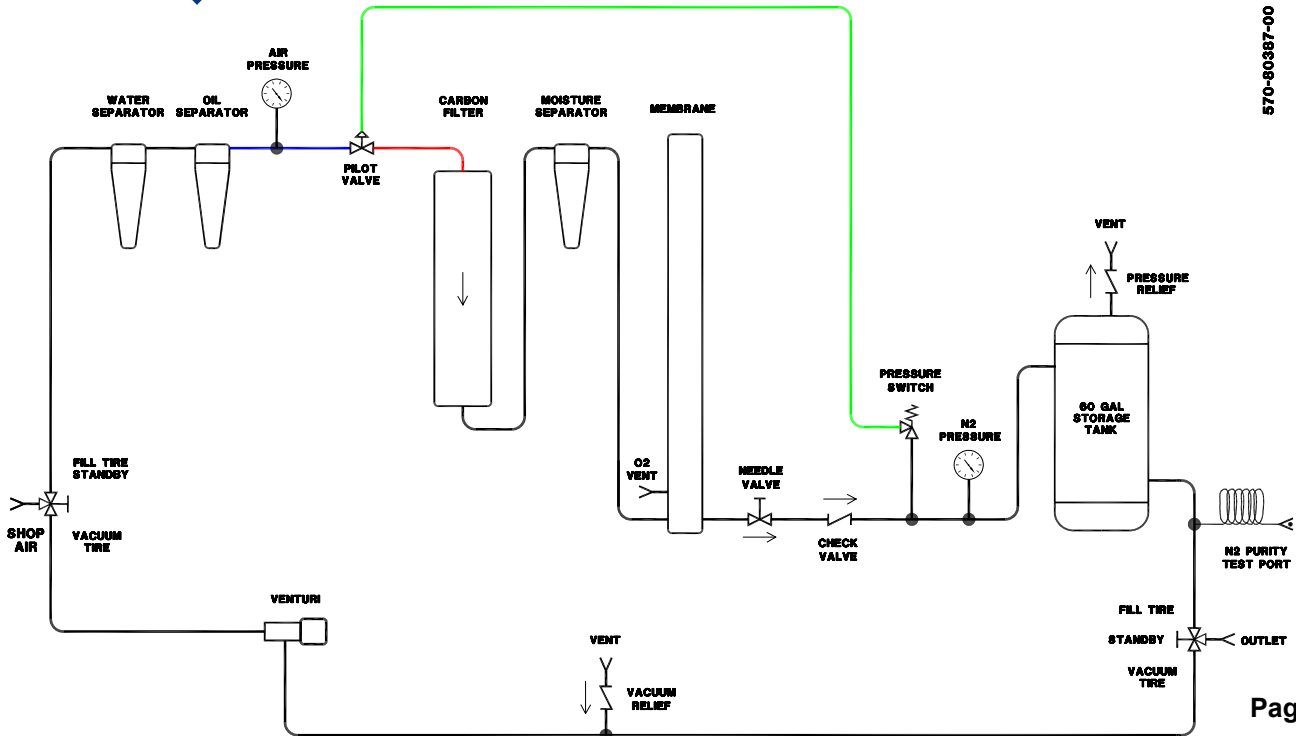
Replacement of the Pilot Valve requires special attention to the three lines which connect to it and...

The photos show the correct connection of the Pilot Valve and the important requirement of removing the plastic plug from the port which has no connection.

**MOST IMPORTANT
 THE PLASTIC PLUG
 MUST BE REMOVED**
